# Management Summary of Archaeological Investigations at the Robert G. and Cornelia S. Fitzgerald House – Pauli Murray Family Home, Durham County, North Carolina

Submitted 19 July 2017 to The Pauli Murray Project Box 90403 Durham, NC 27708

Submitted by Anna S. Agbe Davies, PhD, J. Eric Deetz, MA, RPA

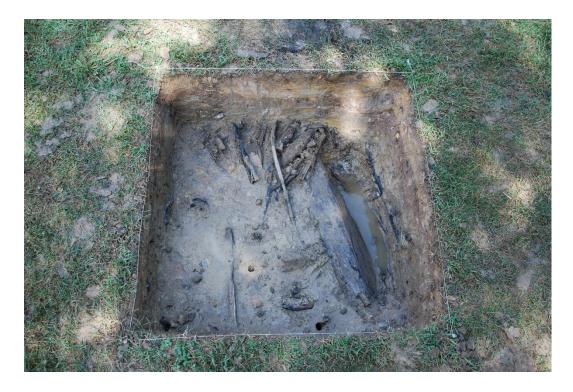
The preliminary planning for the site proposes a motor vehicle approach and ADA access on the north side of the house. Seven shovel tests were excavated in the area to the north of the house which was not included in the test survey of 2016. The soils in this area appeared to be heavily disturbed and consisted of recent clay fill. A one meter by one meter test unit (Test Unit 5) was excavated to better understand the soil layers encountered in the shovel test pits. The excavation of this test unit confirmed that the fill was very recent and contents displayed no evidence of decomposition (Figure 1).

Figure 1. Test Unit 5 which contained undecomposed brush, evidence of recent fill.

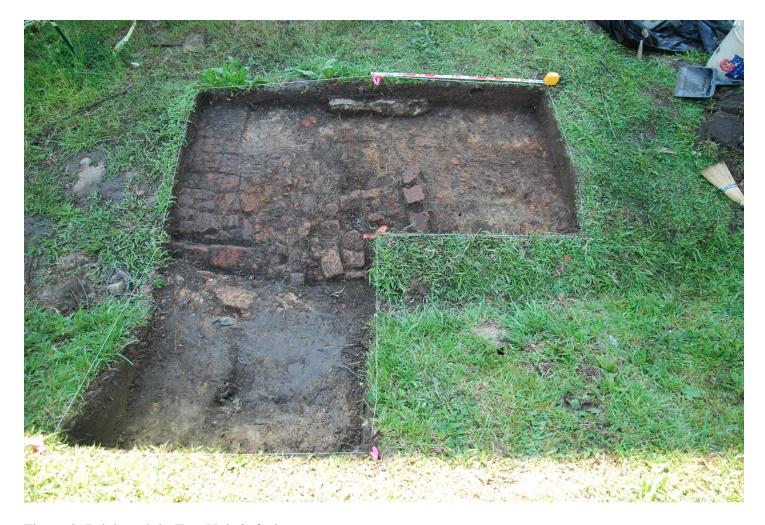
Test Unit 3 was placed at the southwest corner of the footprint of the old rear addition. The unit encompassed three 1-meter squares. Within the unit there was evidence of a drainage ditch running north south that was open until at least the 1990s. In the east half of the unit was evidence of at least two episodes of brick work that appears to be placed to drain water away from the back of the house (Figure 2). The bricks were underfired, handmade bricks. Given the fact that the Fitzgeralds were brick makers (Anderson 2011:133-134), it is likely that this brick work is contemporary with their occupation of the house. Later occupants would not necessarily have had access to such bricks unsuitable for building or sale.

Figure 2. Brickwork in Test Unit 3. facing east.

The brick drainage features west of the corners of the rear shed addition that were identified in Test Units 3 and 4 relate directly to the ongoing struggles that the Fitzgeralds had with water flowing through the property caused, or at least exacerbated by, the landscaping of the neighboring cemetery. These issues were significant enough to be immortalized in Murray's family history *Proud Shoes* (Murray 1999) and represent some of the many social justice issues faced by the family.

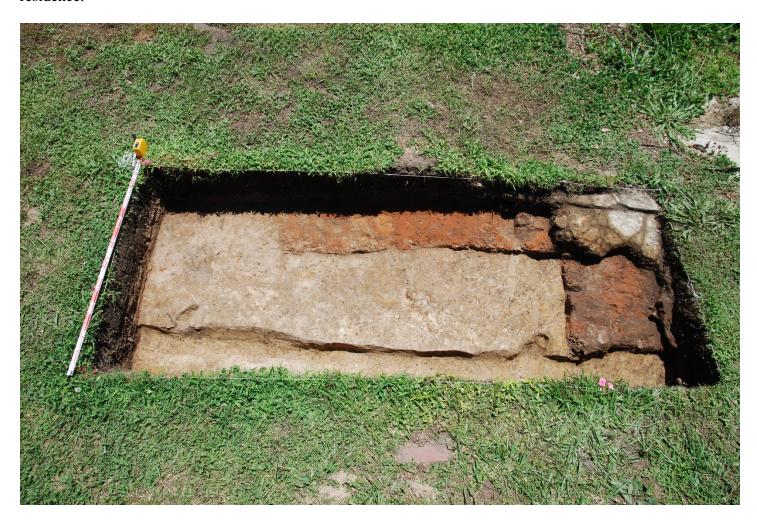
Test Unit 4 measured 1 x 2.5 meters (Figure 3). The upper levels of this test unit uncovered a midden of household refuse that appears to be from the first half of the twentieth century, which includes the period of significance. This midden or sheet refuse extends another five meters to the north (based on shovel test evidence) but no farther into the north yard. In addition, as in Test Unit 3, there was evidence of at least two episodes of dry laid bricks placed to facilitate drainage away from the west side of the house. Unlike in Test Unit 3, in Test Unit 4 the drainage ditch appeared to have been filled at an early date and was not open in the latter part of the twentieth century. Therefore, the fill of the ditch likely dates to the period of Murray's residence.

Figure 3. Test Unit 4 facing east showing the brick work with the drainage ditch at the bottom of the photo.

The domestic refuse scatter or midden identified in Test Unit 4 dates to the late nineteenth- to mid-twentieth-century and falls within the period of significance. While the material cannot be definitively attributed to Pauli Murray, analysis of the artifacts from this midden would provide additional information about the everyday life of the household during her residence.

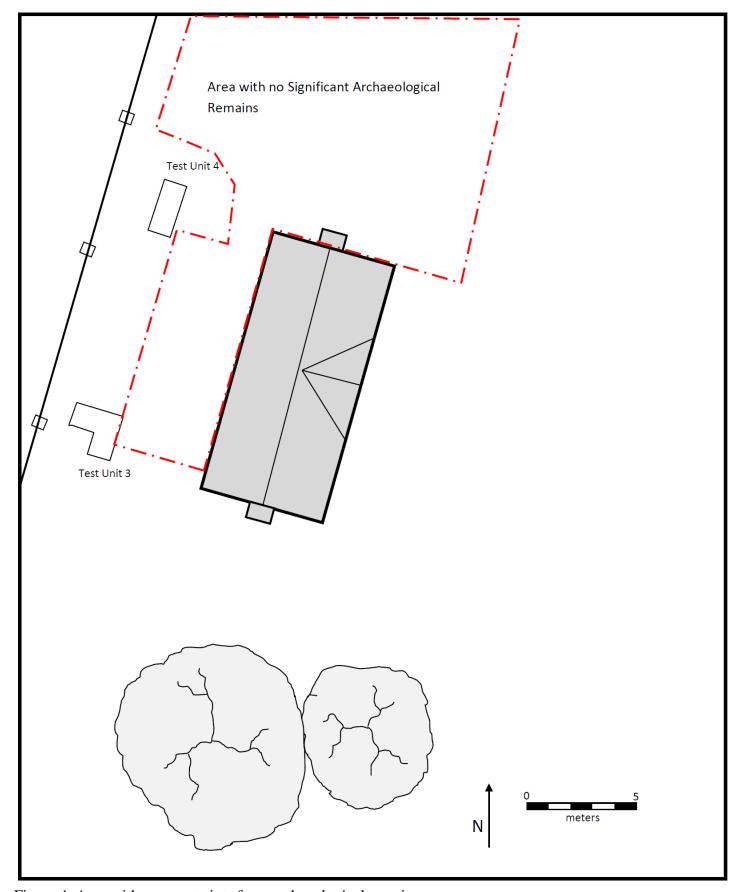
In addition to these areas with great archaeological significance, the testing also indicates there are areas with no archaeological constraints. These include the area within the footprint of the old addition and the disturbed areas north of the house (Figure 4).

Figure 4. Area with no constraints from archaeological remains.

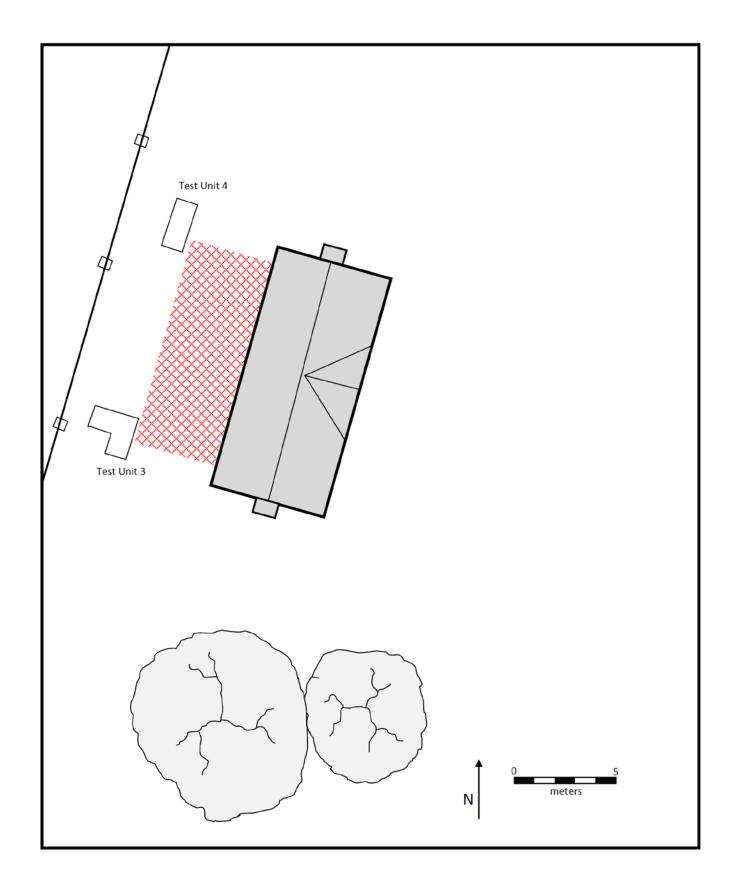
Figure 5. Approximate footprint of the old addition.

If the proposed construction to restore the addition to the back of the house (Figure 5) takes place entirely within the footprint of the old addition, then no significant intact archaeological remains will be affected. Given the presence of intact archaeological features very close by, however, it is recommended that any excavation along the perimeter of the addition's footprint be done by hand. At distances farther than 5 meters northward, construction may proceed without fear of damaging significant archaeological materials.

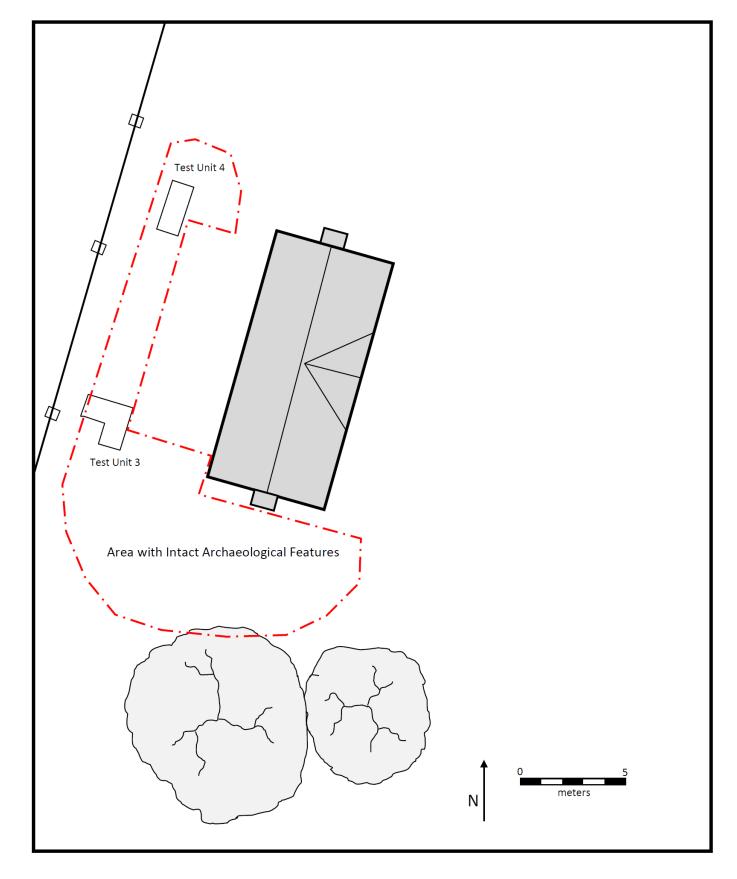
In summary, the areas to the west of the proposed addition and to the south of the house do contain intact archaeological remains (Figure 6). These features all relate to the attempts at managing the runoff from the cemetery. The purpose of the long-range plans for the Fitzgerald house are not to develop an historic house museum as much as a space to reflect on and continue the works of Pauli Murray, however the intact brick drainage features in particular represent an opportunity for a tangible interpretive link between the history of the site and the proposed modern use. These physical remains beyond the house could aid in placing the site and the Fitzgerald's experience in historical context.

Figure 6. Areas north and west of the house where there are intact archaeological features.

Any soil disturbance to the west and south of the house and addition could have an adverse effect on these archaeological remains, therefore, any excavation or construction outside of the footprint of the original addition should be designed in a way to minimize damage to these features.

If the construction cannot be completed within the above parameters, then it would be recommended that a Phase III archaeological data recovery project be undertaken to preserve the data that would be potentially lost.
